Docket No. 217 – Development and Management Plan Inspection

Date: February 9, 2005

Location: Norwalk Substation Expansion

Location: Plumtree Substation Expansion , Bethel

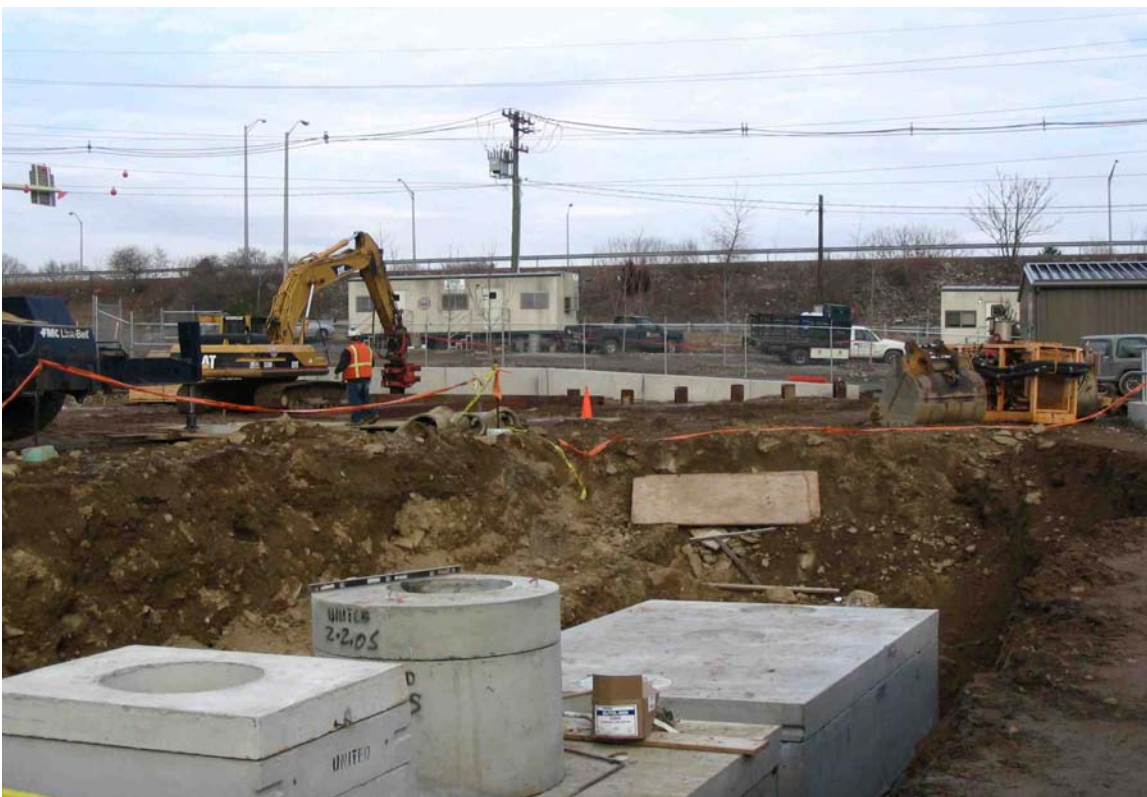
View of the excavation and backfill near wall #3. All soil remains well within the site. 2/9/05

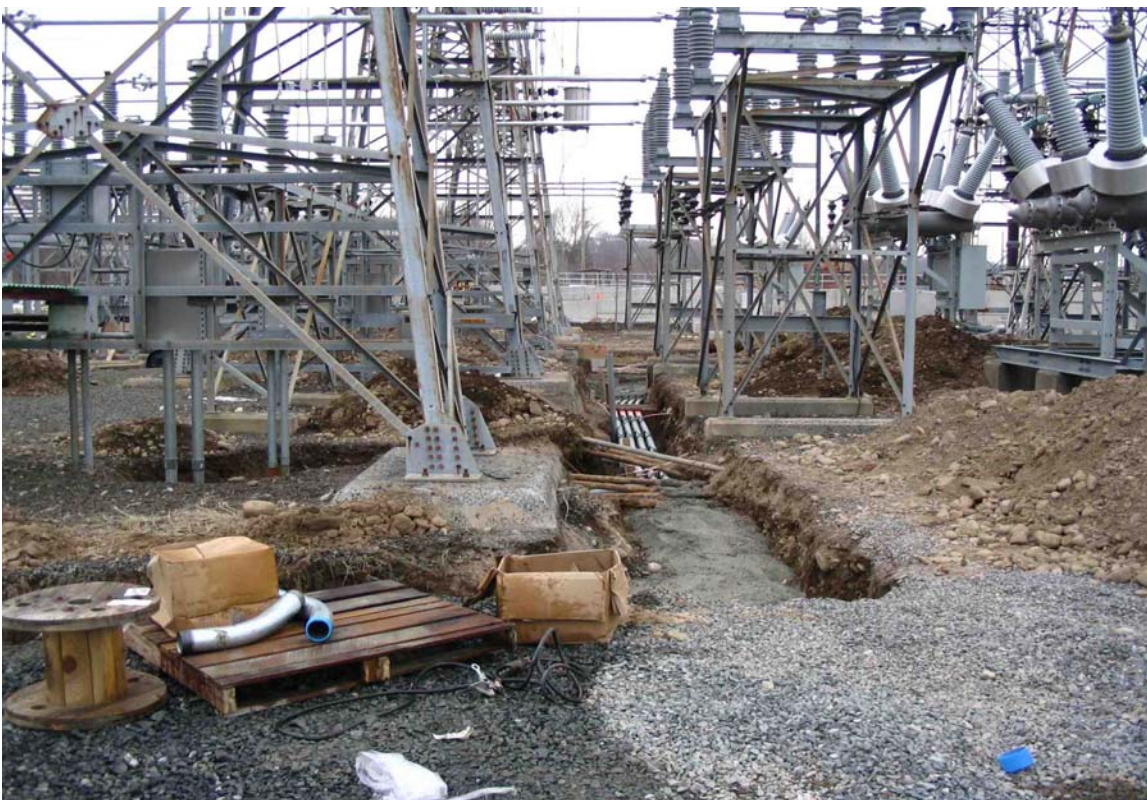
View of the cable work and excavation ongoing within the charged yard. 2/9/05

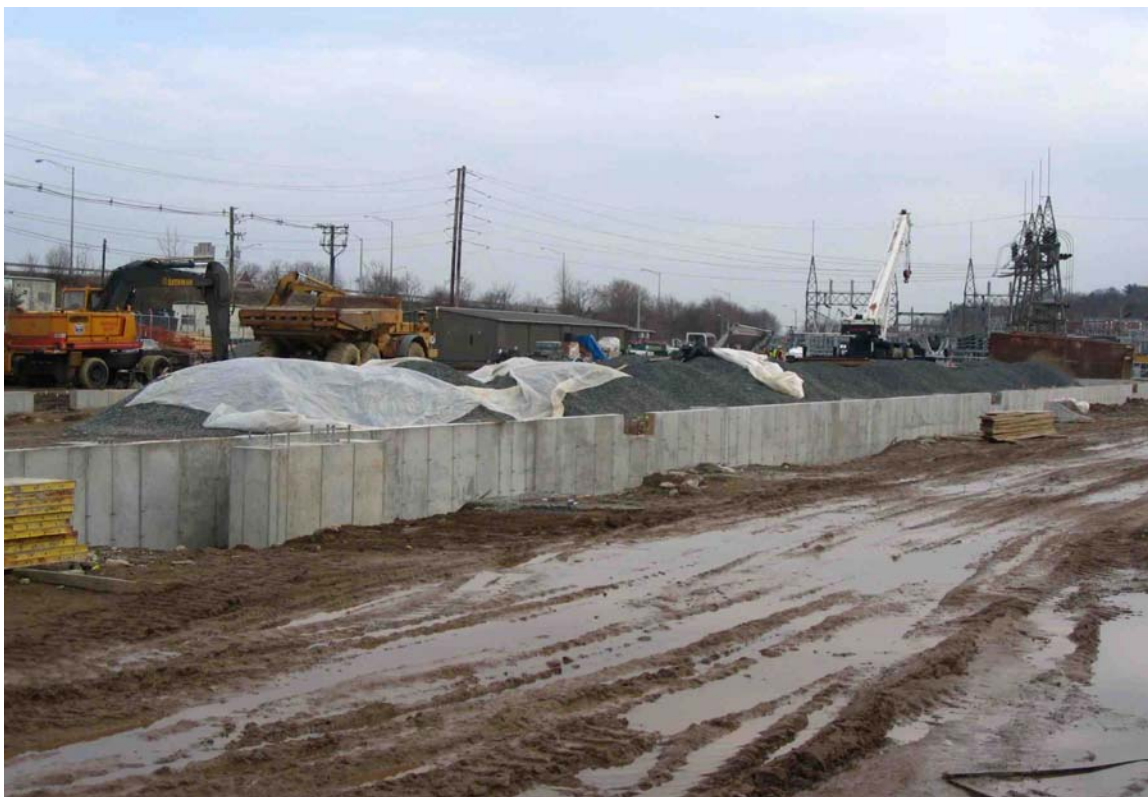
Overall view of the GIS building work. 2/9/05

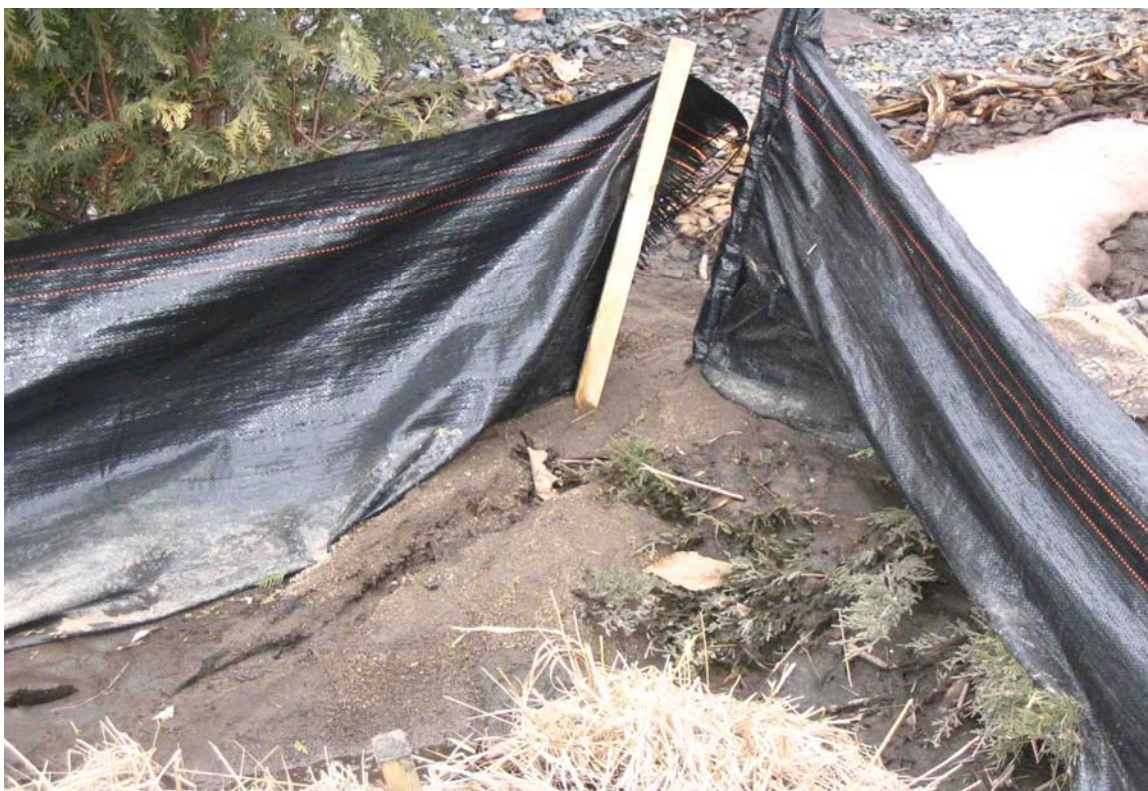
- The flared inlet near the Rt 7 ramp requires repair of the silt fence control. It is receiving obvious stormwater flows and sediment has built up around the controls. The haybale is almost buried and should be cleared of sediment. 2/9/05	- Repair silt fence and continue to monitor until stabilized as the surrounding area is still bare soil. Until vegetative cover establishes, the potential for sedimentation in this area remains. 1/27-2/9/05

The protected inlet near the Route 7 ramp continues to receive a mixture of roadway sand and soil from the landscaped areas along the substation. The silt fence requires repair and the area should be cleared. 2/9/05

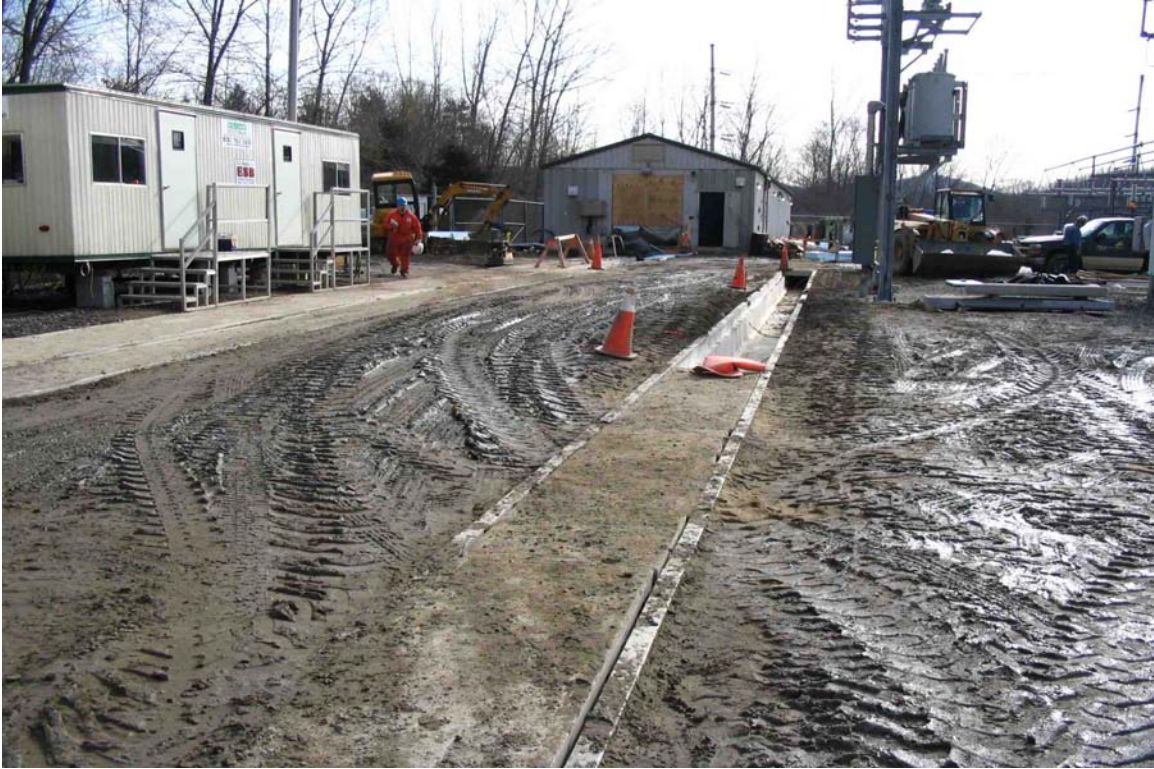
Plumtree Substation: View of the continued work on the cable trenches. 2/9/05

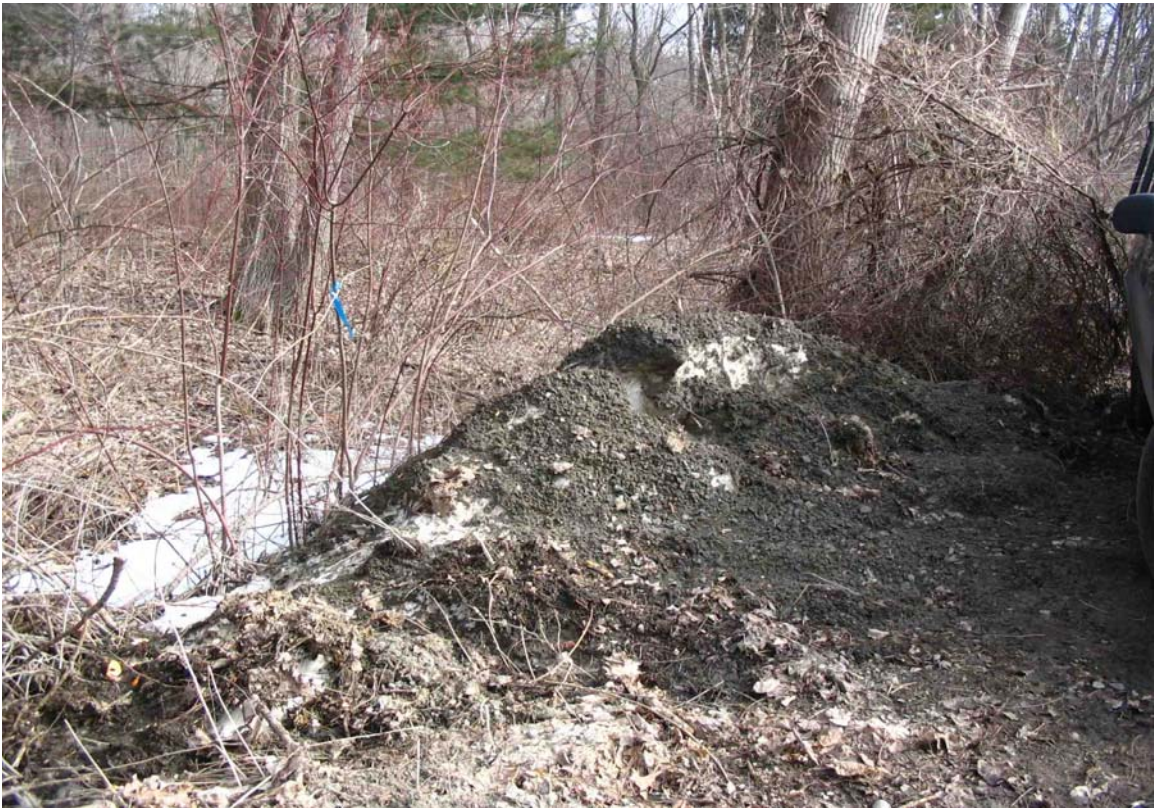
Areas of Inspection	Observation	Recommended Action
	- A small pile of plowed snow with stone and soil was pushed immediately adjacent to the edge of the wetland. When the pile melts, sedimentation to the wetland is likely. 2/9/05	- The pile will be spread back out across the driveway to keep the sediments out of the wetland. 2/9/05

A plowed pile of snow mixed with soil and stone was placed immediately adjacent to the wetland. The pile will be spread back into the driveway to avoid sedimentation. 2/9/05
